REPORT

Richview SC22 Incident - January 30, 2007

Document ID	IESO_REP_0386
Document Name	Richview SC22 Incident - January 30, 2007
Issue	Issue 1.0
Reason for Issue	First release.
Effective Date	March 12, 2007

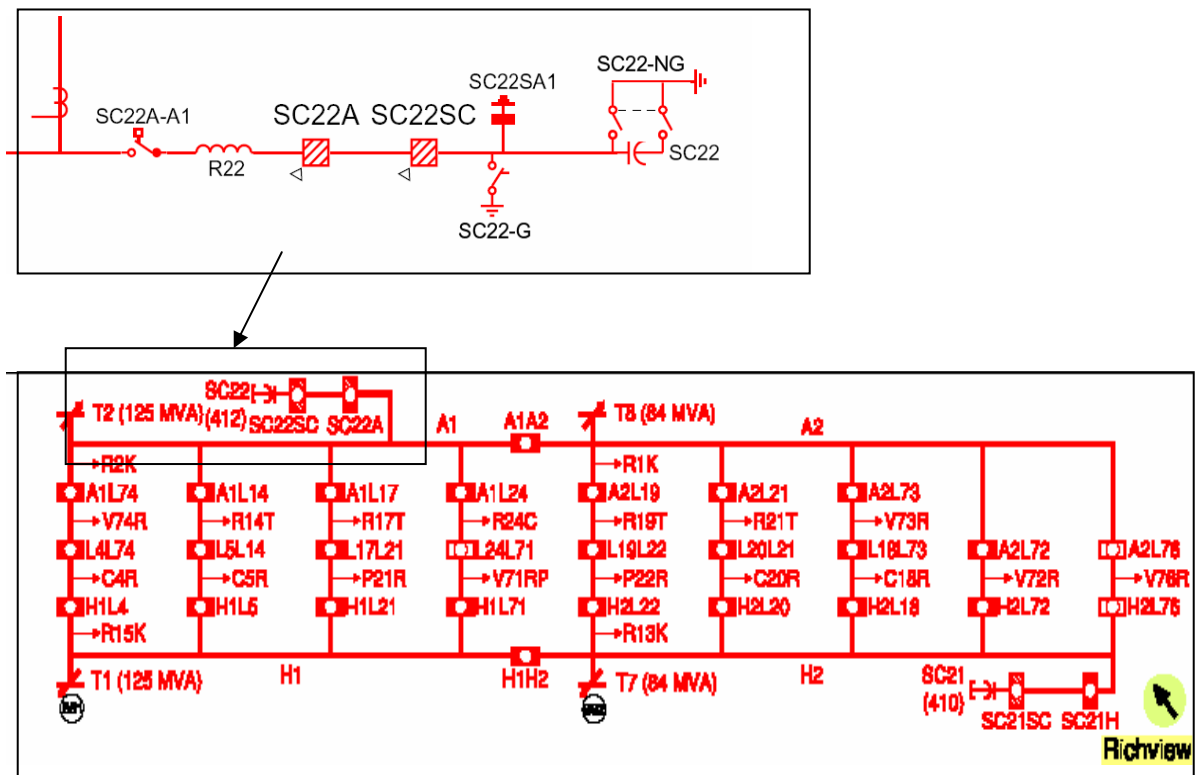
Figure 1: Richview Station Diagram

The Richview 230 kV yard is comprised of 20 circuits, 31 air blast breakers and two 412 MX capacitors. Current limiting reactors were installed, in part to eliminate oscillations that occur between two capacitors when switching one capacitor into service while the second is in service. The capacitor breakers have been sized based on the current limiting reactors being in service.

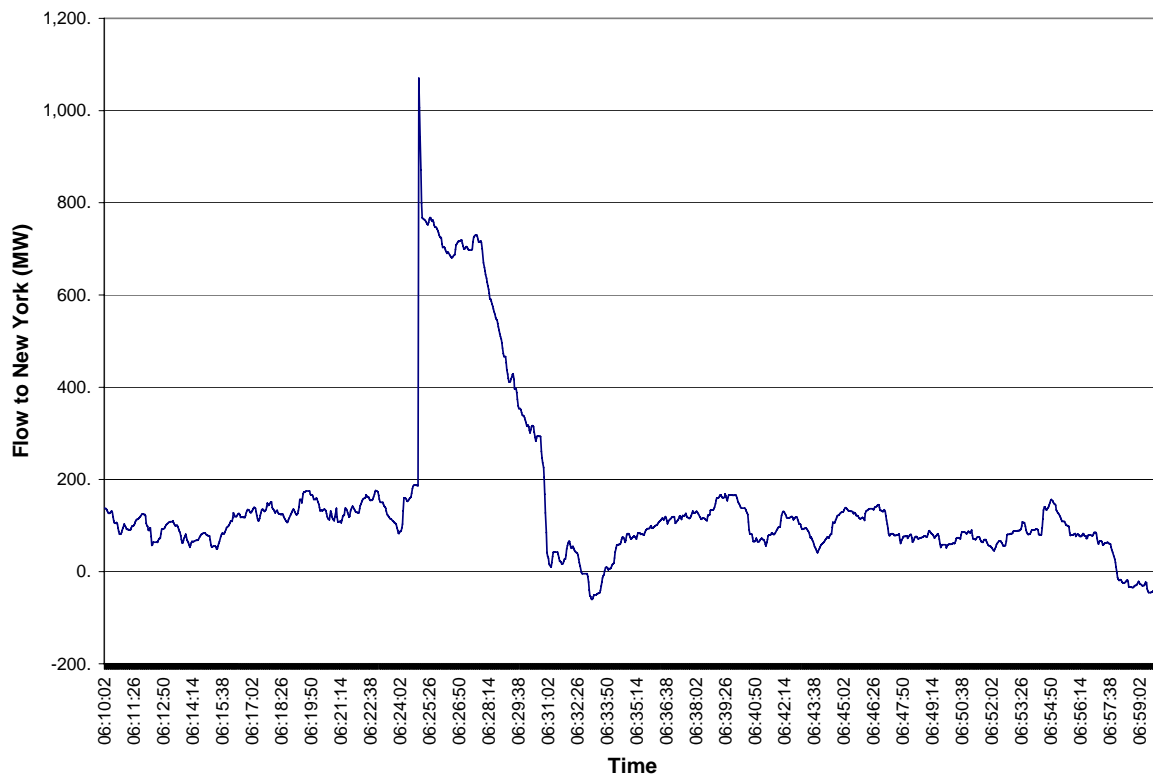
Figure 3: Ontario to New York Tieline Flow – January 30th, 2007

Immediately following the incident and as direct consequence of the load loss in Ontario, flows on the New York interface increased by 880 MW out of Ontario to 1062 MW, 45% of the intertie’s total transfer capability. Flows on the Michigan interface increased by 600 MW out of Ontario to 1070 MW, 54% of the intertie’s total transfer capability. New York and Michigan flows stabilized at approximately 100 MW and 350 MW out of Ontario respectively after ACE was returned to normal values.

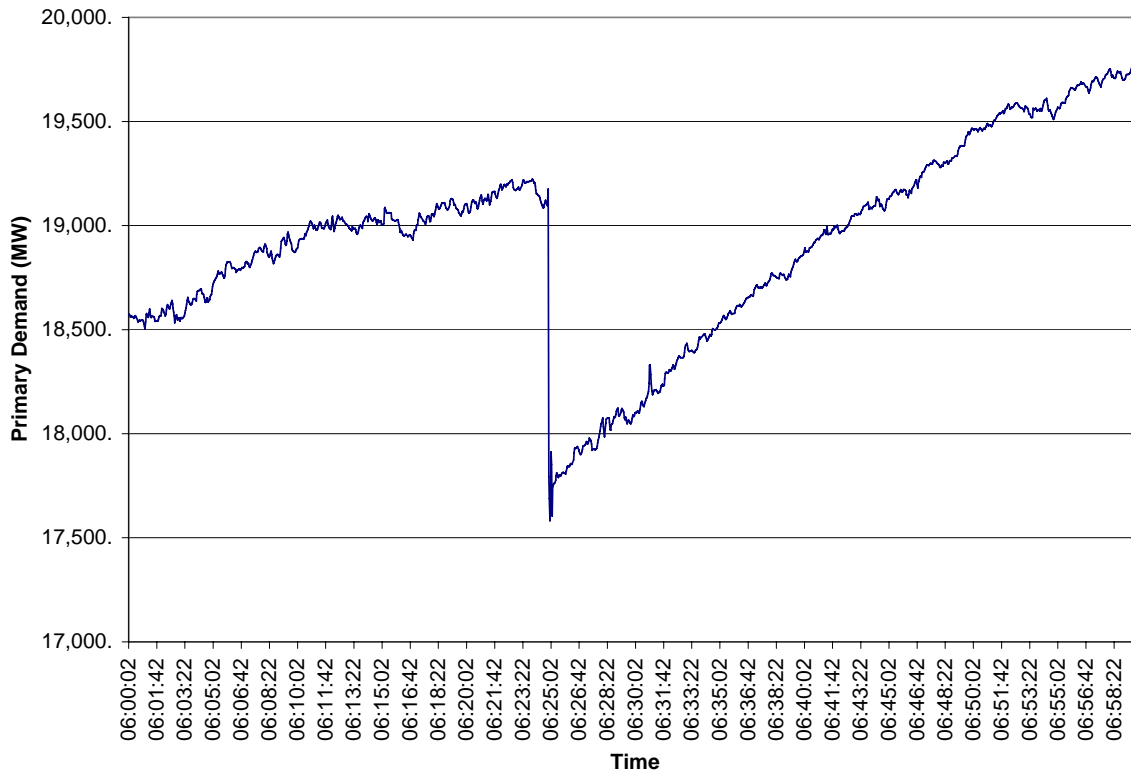
Figure 5: Ontario Primary Demand – January 30, 2007

Approximately 1500 MW of load was removed from the Ontario grid due to the fault at Richview. A sharp drop was observed in Ontario Demand, which was approximately 19175 MW pre-fault and fell to approximately 17690 MW post.

Within 20 minutes of the initial event, the 1500 MW load loss had been recovered and within an hour the expected normal load pickup was being observed

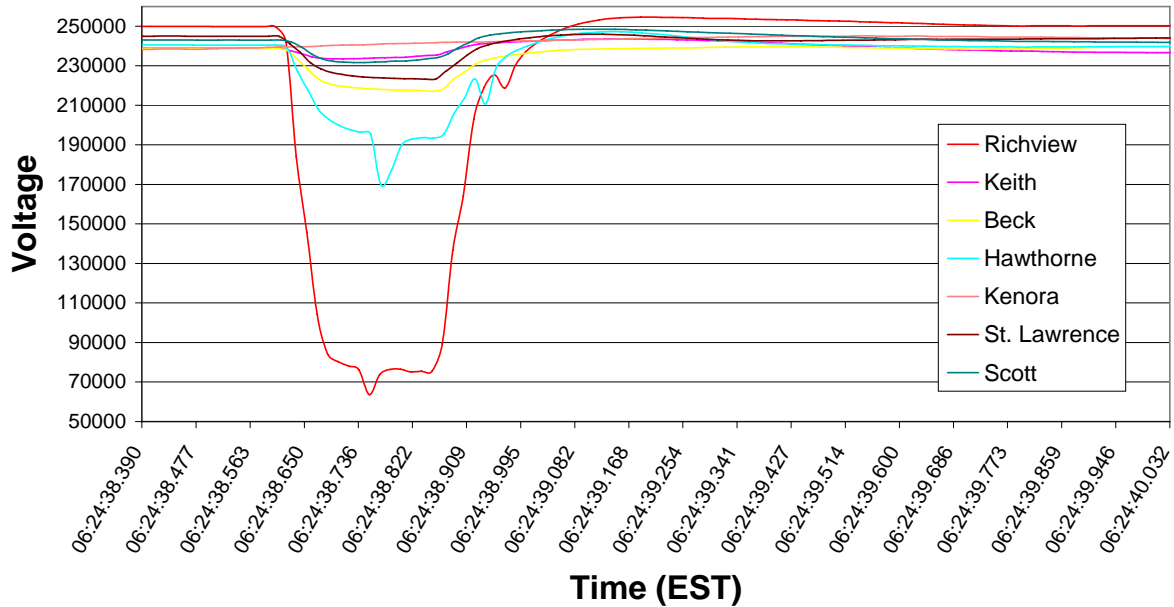
Figure 6: Voltage Fluctuations – January 30, 2007

During the 3-phase fault the 230kV voltages at Richview decreased from 250 kV to 75 kV. For the duration of the fault, low voltages were also observed throughout the grid in Southern Ontario, momentarily dropping the 230 kV voltages by approximately 80 kV in Ottawa, 20 kV in Niagara and 10 kV in Sarnia.

As a result of the temporary decrease in voltage, a significant amount of load was lost in the Greater Toronto Area (GTA). The significant load loss, coincident with the fault being

cleared, resulted in a system which had reactive resources (i.e. capacitors) in service for 19000 MW of load, with only 17500 MW of load in service. This caused the system voltages to increase. In order to control the high system voltage Detweiler SC12 and Burlington SC21 capacitors were requested out of service.

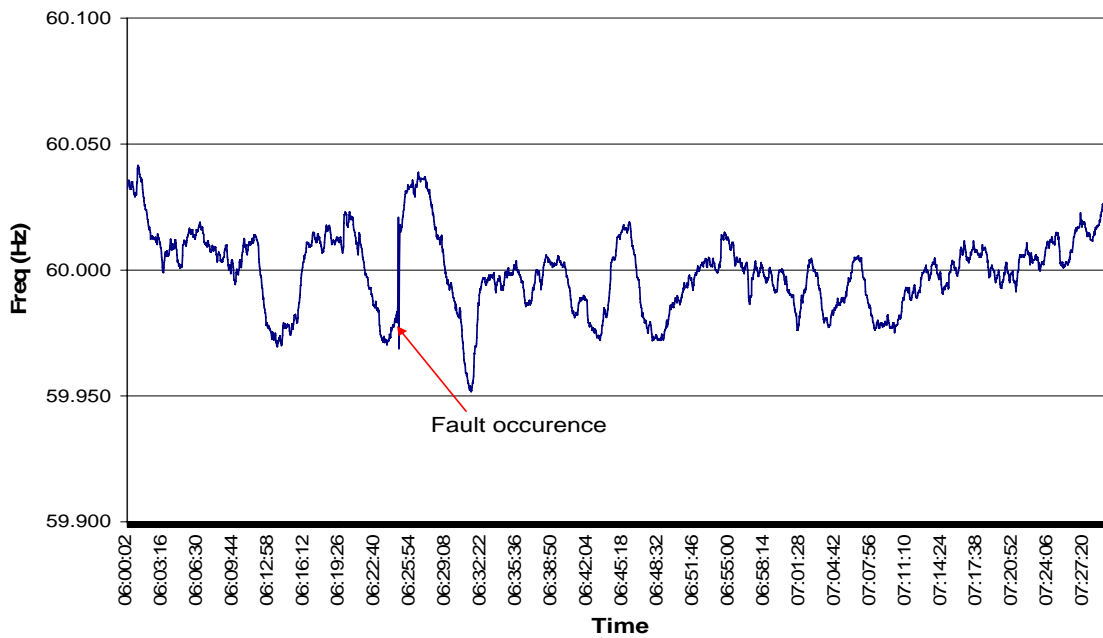
Figure 7: System Frequency Oscillations – January 30, 2007

Local frequency oscillations occurred across Southern Ontario and were well damped within 300 ms. The oscillations were consistent with what would be expected from a normally cleared fault on the system.

As shown in Figure 7, the system frequency experienced much smaller variations between 59.952 and 60.04 Hz, which are well within normal operating criteria.

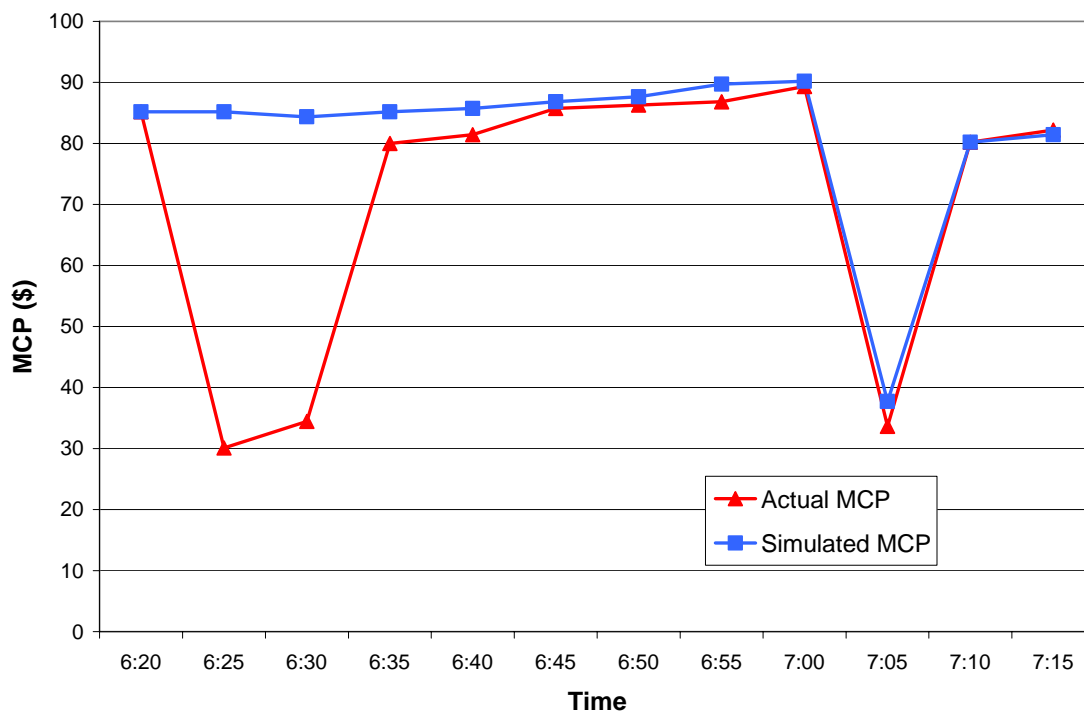
Figure 8: Actual vs. Simulated Market Clearing Price – January 30th, 2007

With the loss of 1500 MW of load the market clearing price (MCP) dropped from \$85.19 to \$30.10. MCPs were simulated based on the primary demand that would have been expected between the time of the incident and when the primary demand recovered (Interval 4 of HE7 and Interval 3 of HE8).
